Installed Beryllium Containing Materials – Final Report

**BHSC Spring Webinar
May 14, 2015**

Gary E Whitney, CIH
Occupational Safety & Health Division
Los Alamos National Laboratory

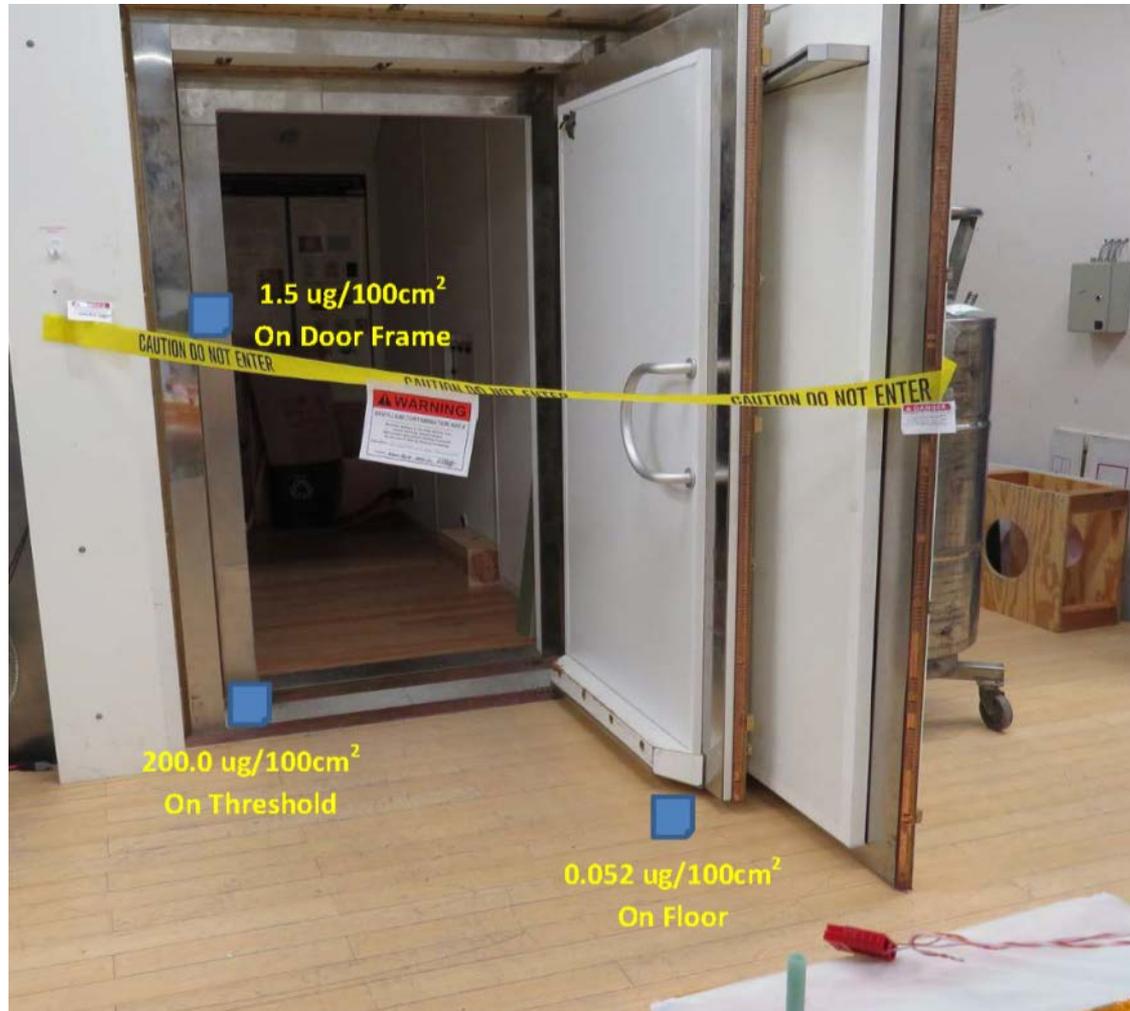
Location of Contamination

- 28 follow-up samples collected in the shielded room and adjacent areas outside room.
- Three samples on door & frame were found to have elevated beryllium contamination (2.4, 4.3, and 5.0 ug/100 cm²).
- All other samples below 0.2 ug/100 cm². Most below LOQ.
- No contamination spread beyond door.
- Sampling of undisturbed horizontal surfaces gave no indication of airborne beryllium.

This general pattern was observed when beryllium contamination was found. Contamination was limited to the finger stock, contact points, and floor at doorway

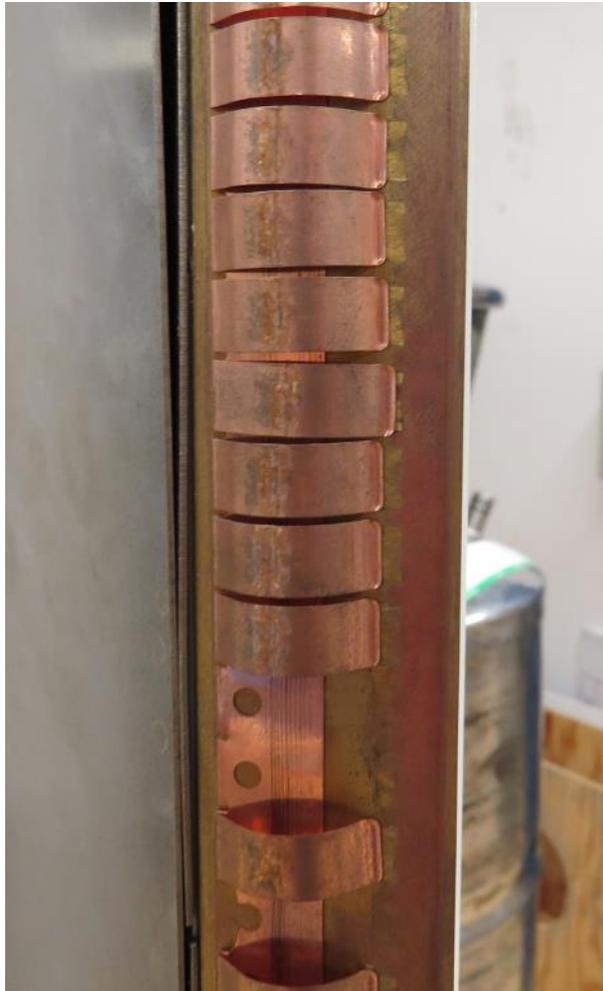
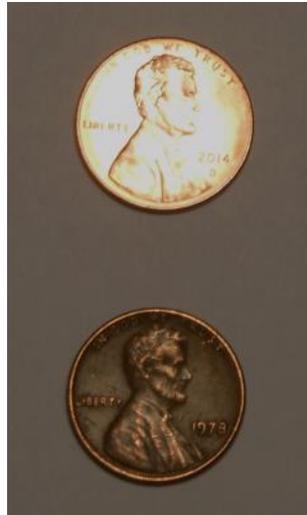
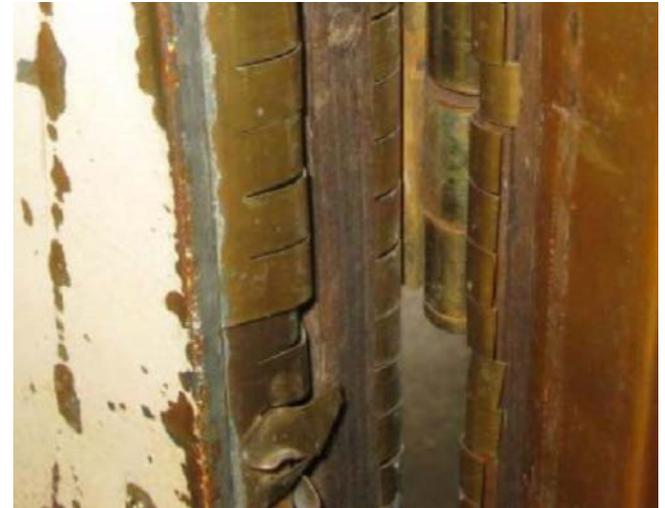
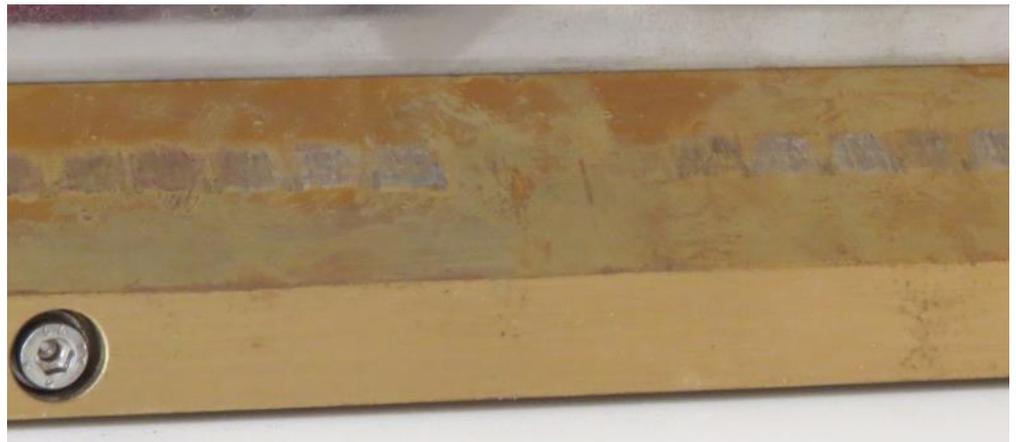
Example of Worn/Damaged Finger Stock

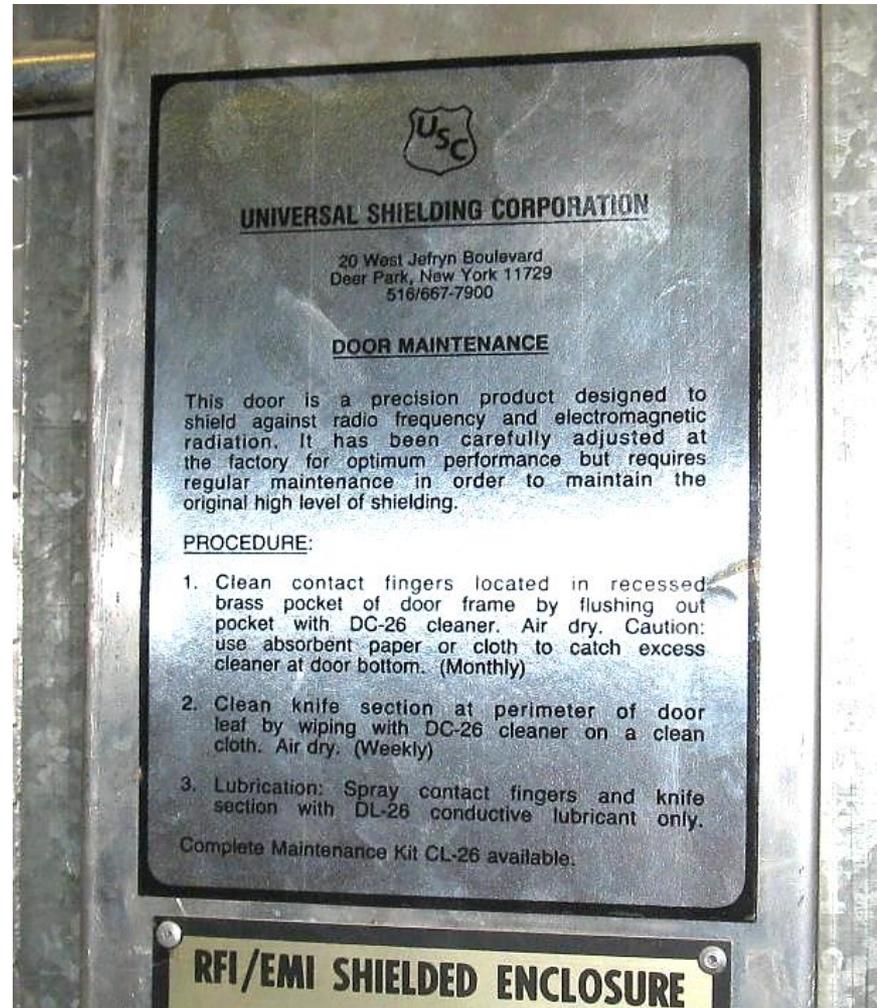
Cleaning/Lubricating Finger Stock

Instructions from shielded room manufacturer on cleaning and lubricating the finger stock on a monthly basis.

This was likely intended to maintain RFI shielding performance, but the cleaning would also prevent build-up of beryllium contamination and the lubrication would prevent wear and abrasion of the beryllium containing materials.
