# Beryllium in RFI Shielding Materials

Update on Beryllium Contamination Found on  
Rooms Shielded with Beryllium Copper Materials

Fall Beryllium Health & Safety Committee Meeting  
October 15, 2014

Gary E Whitney, CIH  
Occupational Safety & Health Division  
Los Alamos National Laboratory

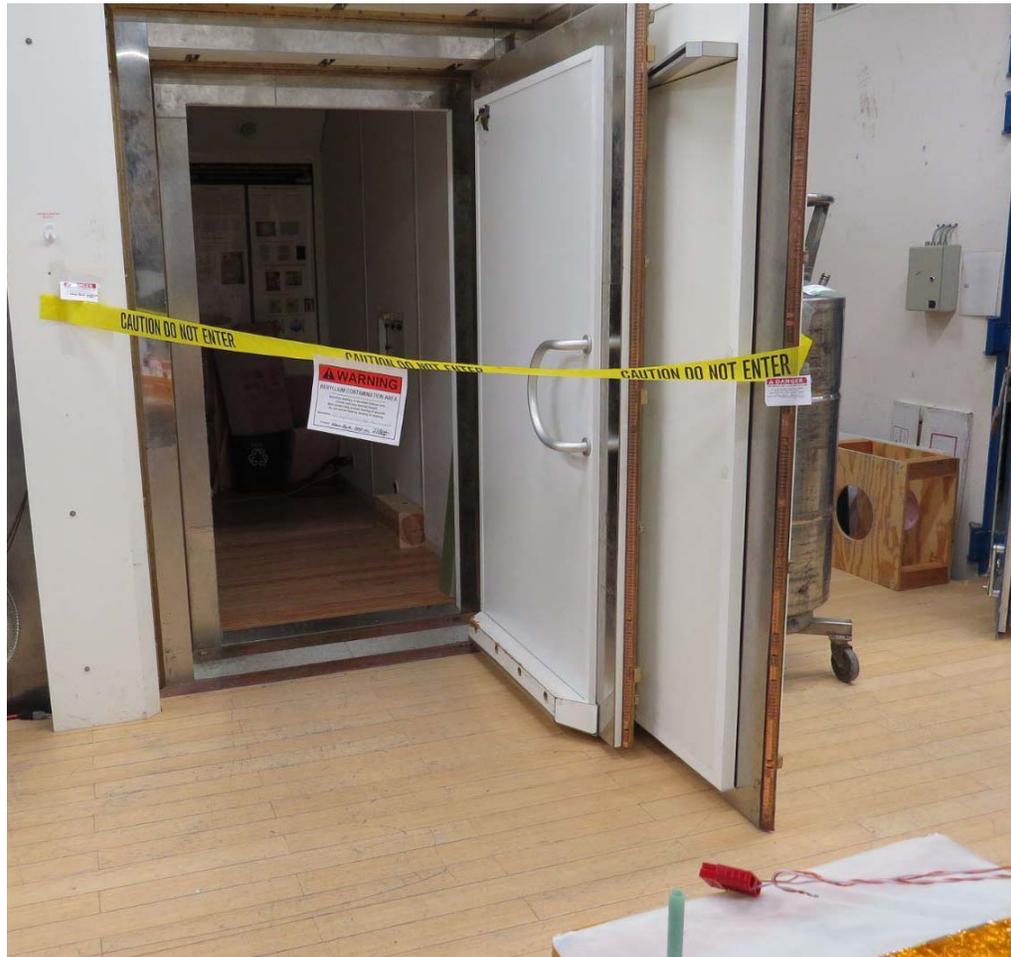
# Shielded Room with Highest Contamination

- In response to the NNSA warning, LANL initiated an Extent of Condition (EOC) evaluation and began sampling shielded rooms and screen rooms across the Laboratory.
- The door frame and threshold of one shielded room was found to have elevated beryllium contamination (maximum 200 ug/100 cm<sup>2</sup>). This was the worst case of all areas evaluated.
- The area was cordoned off, access was restricted, and it was posted as an Accessible Beryllium Contamination Area.
- Additional samples were collected to better characterize the shielded room where beryllium contamination was identified.

- 28 follow-up samples collected in the shielded room and adjacent areas outside room.
- Three samples on door & frame were found to have elevated beryllium contamination (2.4, 4.3, and 5.0 ug/100 cm<sup>2</sup>).
- All other samples below 0.2 ug/cm<sup>2</sup>. Most below LOQ.
- No contamination spread beyond door.
- Sampling of undisturbed horizontal surfaces gave no indication of airborne beryllium.

- Evaluated areas were added to the LANL beryllium inventory.
- Where beryllium contamination above 0.2 ug/100 cm<sup>2</sup> was found, the areas were temporarily posted as Accessible Beryllium Contamination Areas and access was restricted.
- Actions for areas with contamination included:
  - Decontaminating and replacing BeCu finger stock with non-beryllium material. (Some non-contaminated areas also replaced.)
  - Decontaminating and keeping BeCu finger stock in-place with scheduled cleaning and re-sampling.
  - Keep the area posted as contamination area and restrict access.
  - Some areas were not in use and were posted and closed off pending decisions on the final path forward (e.g. D&D).

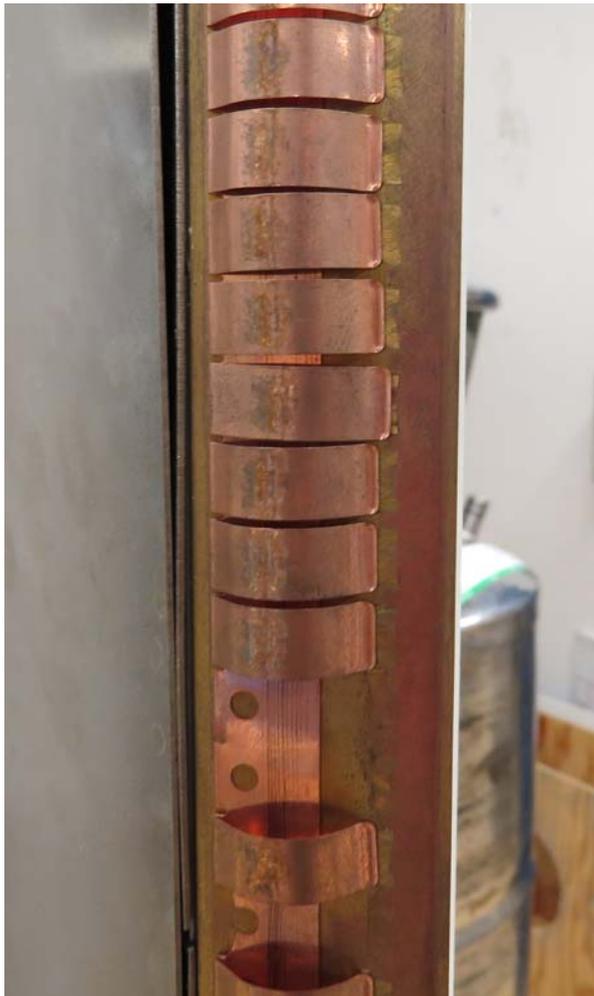
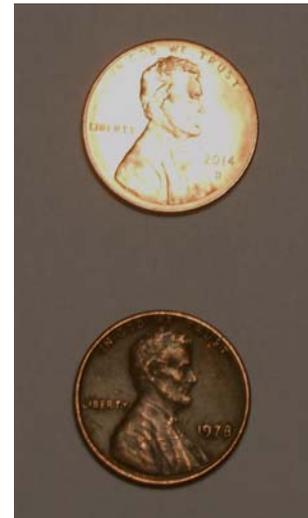
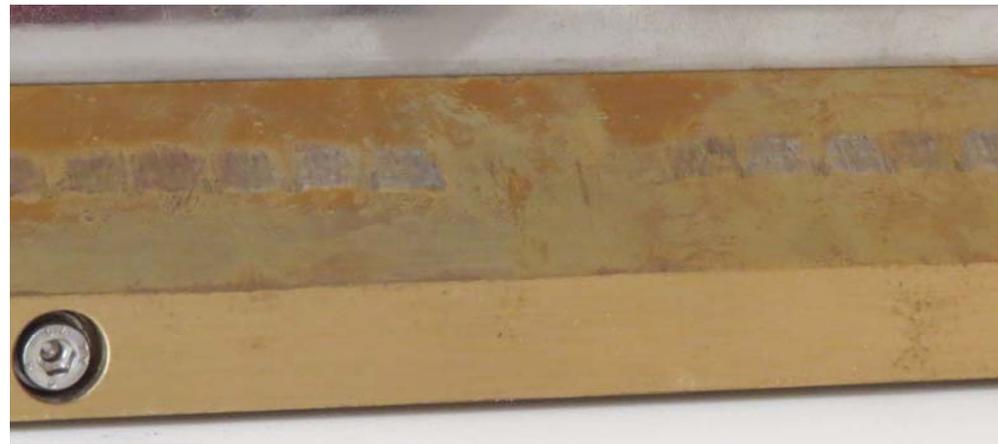
# Example of Worn BeCu Finger Stock

- Twelve of the 40 rooms or structures evaluated had beryllium contamination above 0.2 ug/100 cm<sup>2</sup>. Contamination was limited to doors and frames.
- Note that the finger stock in shielded rooms above 0.2 ug/100 cm<sup>2</sup> tended to showed evidence of wear with shiny-bright metal contact points, abrasion marks, and sometimes broken finger stock.
- Finger stock for the shielded rooms with no contamination concerns tended to have a darker, dull patina and only slight evidence of wear and abrasion. Like the difference between an old and new penny.
