# Beryllium in RFI Shielding Materials

Update on Beryllium Contamination Found on  
Rooms Shielded with Beryllium Copper Materials

Fall Beryllium Health & Safety Committee Meeting  
October 15, 2014

Gary E Whitney, CIH  
Occupational Safety & Health Division  
Los Alamos National Laboratory

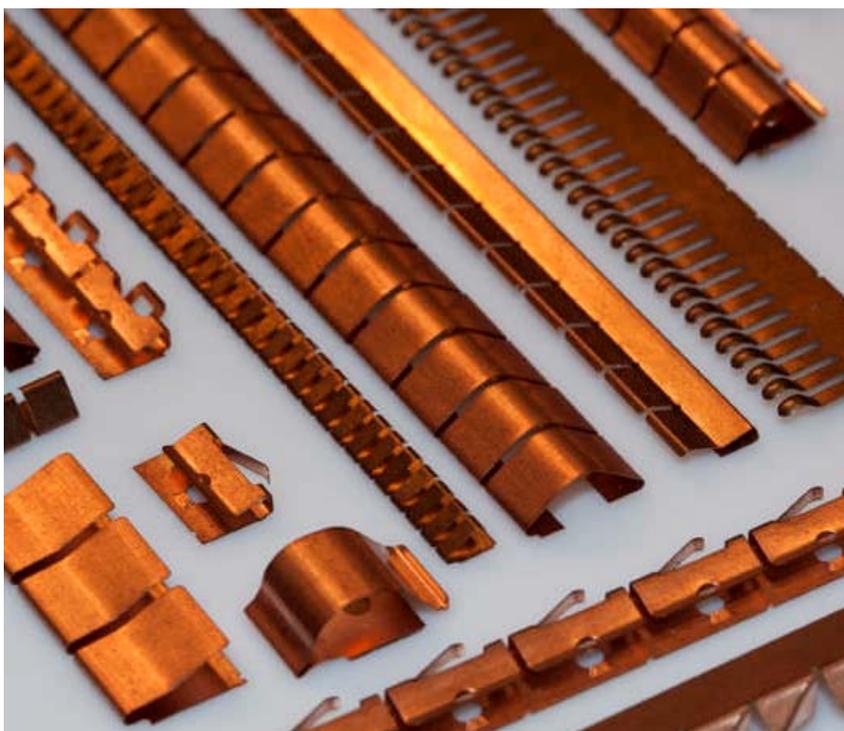
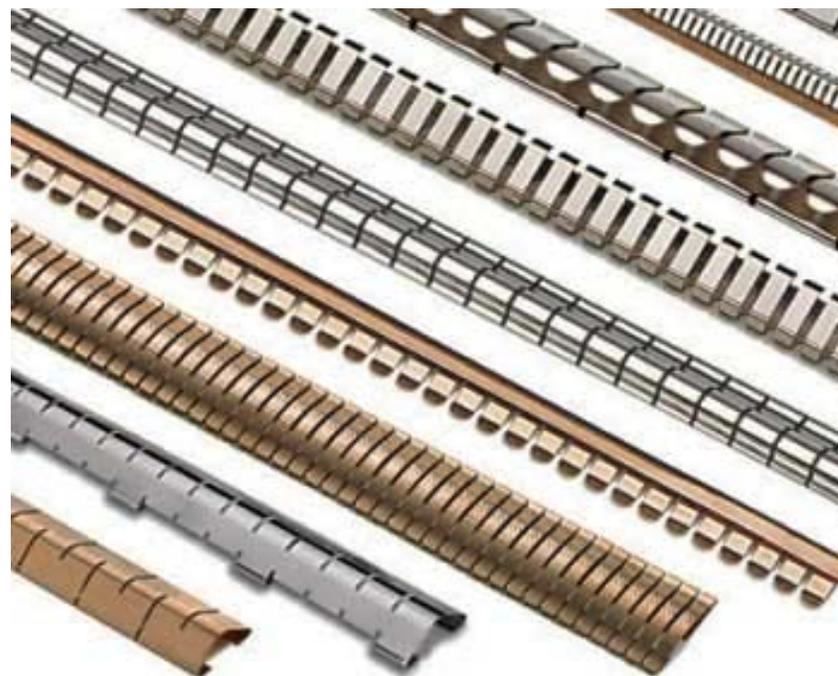
# Examples of BeCu Finger Stock

Beryllium copper finger stock is often installed on door and other openings to provide RF shielding and electrical continuity.
